OPEN-PIT "FILIJALA" NORTHWEST SLOPE STABILIZATION IN ORDER TO REDUCE DAMAGE RISK AND ENVIROMENTAL PROTECTION

Čebašek Vladimir¹, Gojković Nebojša¹

Abstract: The development of the marl exploitation in the open pit "Filijala" caused the instability appearance in northwest final slope area. The location of this part of the mine in relation to surrounding objects demanded stabilization of the slope in order to prevent further spread of damage. For these purposes, a detailed analysis of the current state of slope stability were carried out, which used as a basis for determining appropriate stabilization measures for the slope.

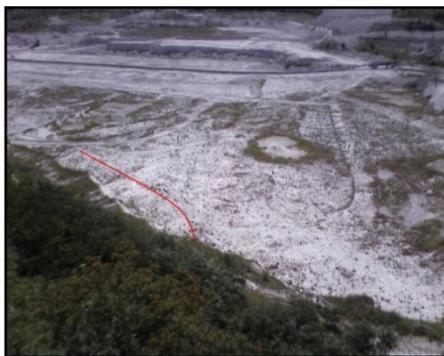
Figure 2 - Direction (—) of appearance of northwestern final slope instability

Instability of the northwestern slope was observed with progress of work on the excavation of marl in the open pit "Filijala". In the field these changes are manifested in deformations - marl complex movements at the bottom of the open-pit at a level of 120 m in this zone, Figures 2 and 3. Open pit mine in this area has come to its exploitation boundaries in the plan, while it was scheduled in the vertical to reach the altitude 80 m.

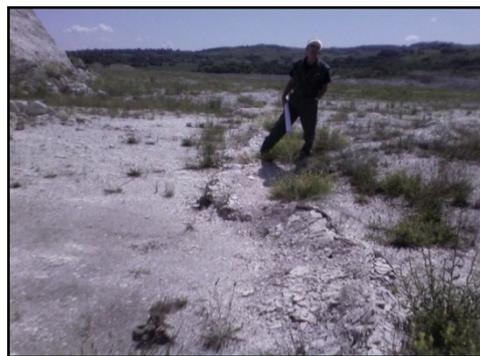
Figure 3 - Marl complex deformations - movements at floor of the open pit (elevation 120)

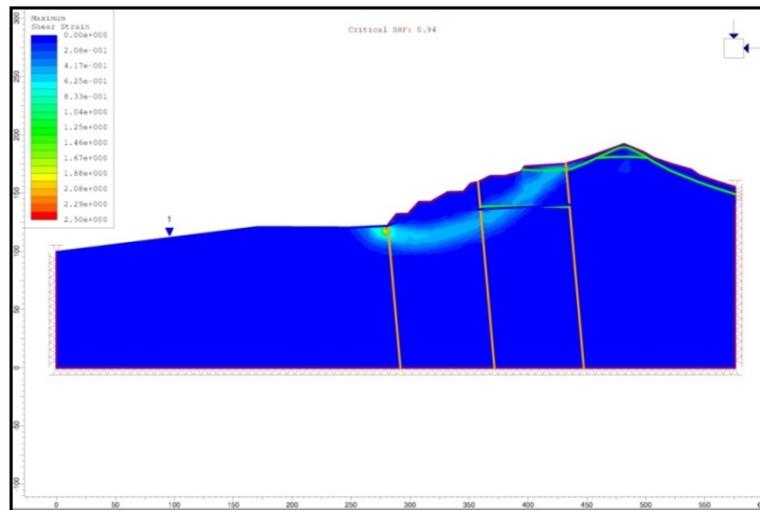
Stability analysis of the current state of final slopes in this part are defined safety factors which amounted to $F_s = 0.94$ (section A - A'), $F_s = 0.84$ (section B - B') and $F_s = 0.90$ (section C - C'). The analysis of the distribution of maximum shear strain

(Figures 11, 12 and 13) shows that the maximum concentration is in the zone immediately below the toe of slope, which is fully consistent with the deformations that were observed at the bottom of the open pit during the field observation. Based on these results it was concluded that it is necessary to carry out stabilization of the final slope in this area.

Figure 11 - Section A - A' slope stability analyses results with the distribution of maximum shear strain (potential slide plane)

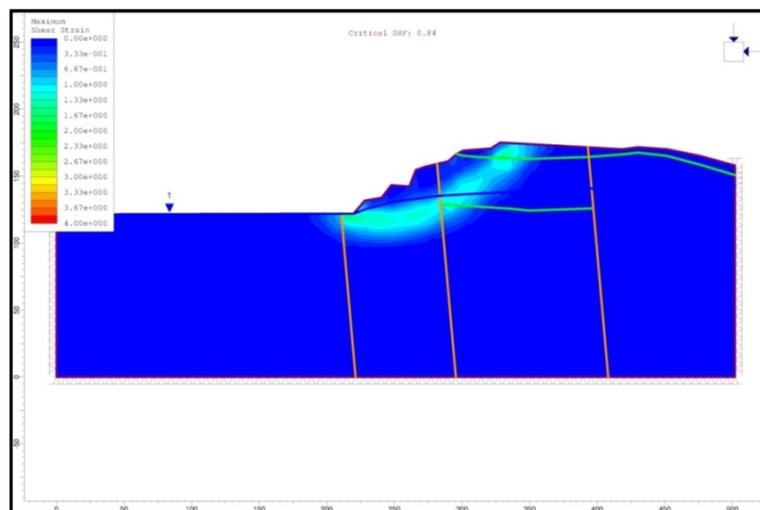
Figure 12 - Section B - B' slope stability analyses results with the distribution of maximum shear strain (potential slide plane)

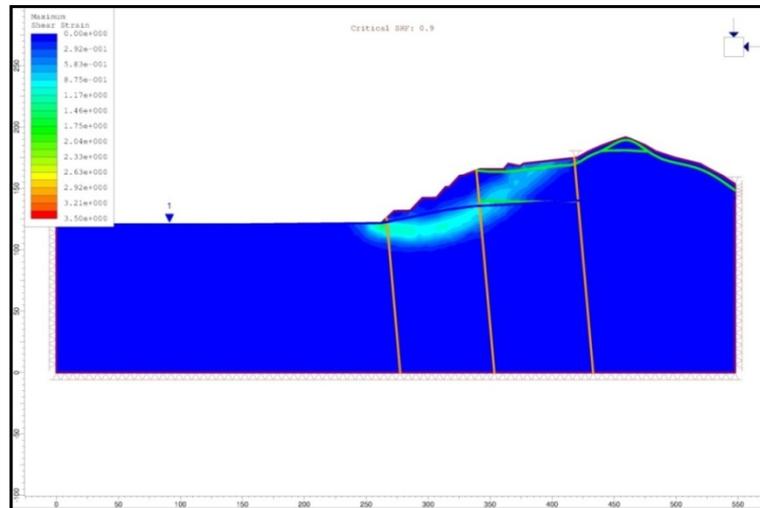
Figure 13 - Section C - C' slope stability analyses results with the distribution of maximum shear strain (potential slide plane)

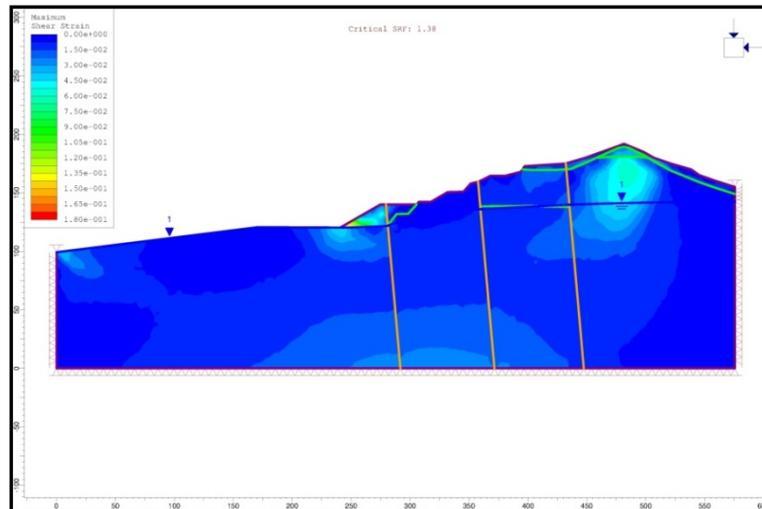
Final slope stability analysis with applied stabilization measures by constructing the counterweight embankments in toe part of the slope in this part have defined the safety factors which amounted $F_s = 1.38$ (section A - A'), $F_s = 1.32$ (section B - B') and $F_s = 1.39$ (section C - C'). The analysis of the distribution of maximum shear strain (Figures 17, 18 and 19) shows that the maximum concentration is in the zone below the toe of embankment slope, which is fully consistent with the required minimum value of safety factor $F_{smin} = 1.30$. Here it should be noted that the potential slide plane with a minimum safety factor of slopes in all analyzed sections with applied stabilization measures is located in the zone of the embankment slope. This indicates that the overall slope with applied stabilization measures safety factor is greater.

Figure 17 - Section A - A' slope stability analyses results with the distribution of maximum shear strain (potential slide plane)

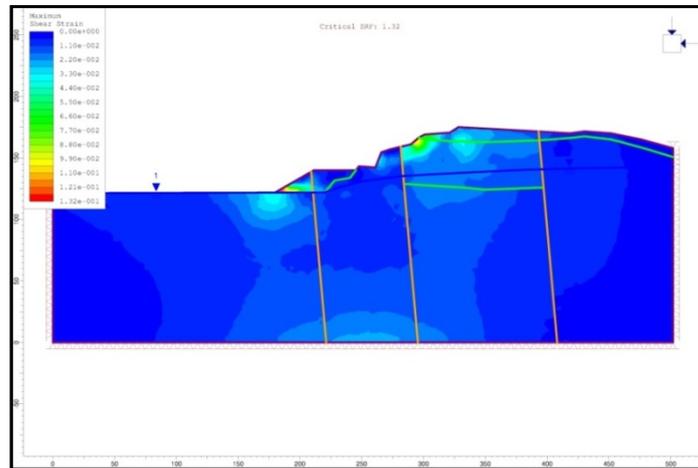
Figure 18 - Section B - B' slope stability analyses results with the distribution of maximum shear strain (potential slide plane)

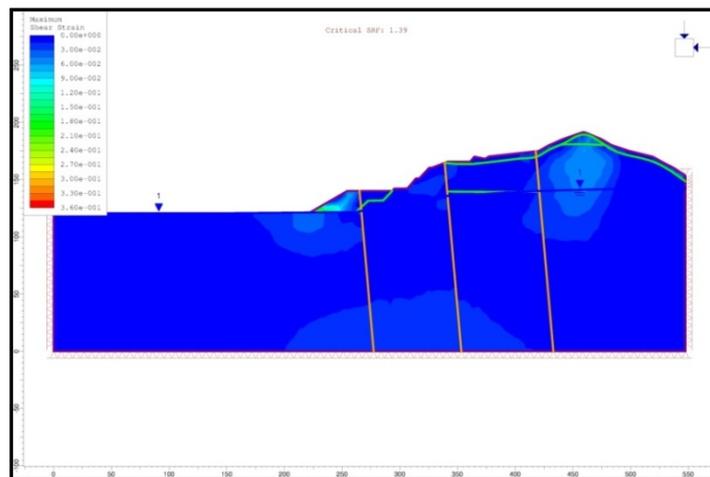
Figure 19 - Section C - C' slope stability analyses results with the distribution of maximum shear strain (potential slide plane)
