## ESTIMATION OF THE QUALITY OF BUILT-IN CONCRETE BY THE ULTRASOUND OBSERVATIONS

**Abstract:** This paper presents results of the propagation velocity investigations of ultrasound waves in the concrete construction - so called non-destructive method - "in situ" due to inspection of concrete quality that is inbuilt into the body of the Durutovići dam, built for the Pljevlja coal mine. By the velocity of ultrasound waves measures, the following parameters will be defined: concrete homogeneity, presence of gaps, cracks and other defects in concrete, as well as concrete quality related to its strength.

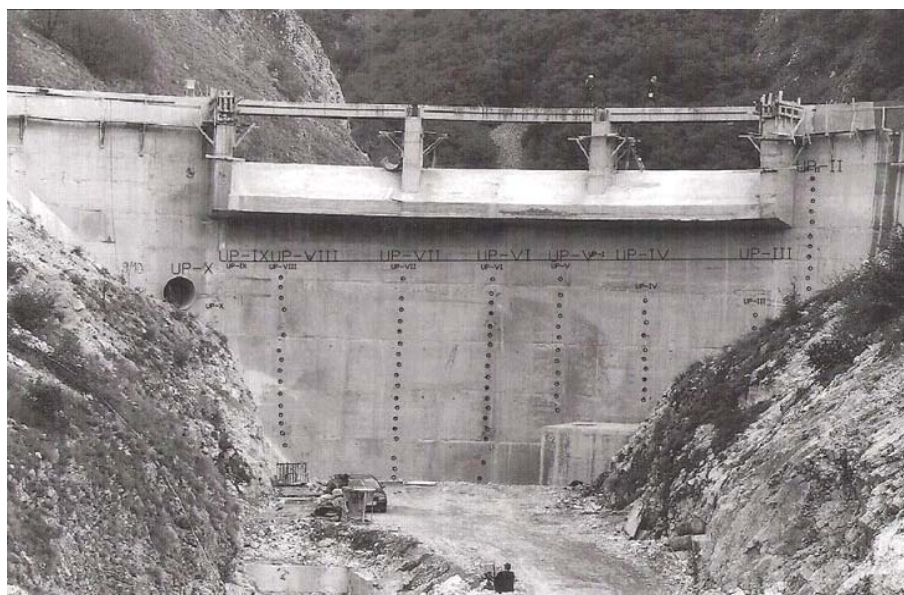
**Figure 5** - Position of profiles and measurement points on the downstream side of the "Durutovići" dam

Position and a profile of measurement points on the downstream side the Durutovic dam are shown in Figure 5. On the upstream side, access was possible from the scaffolding that was constructed for injection of horizontal concrete extensions, while the downstream side access was possible from the basket (of the crane). The left and right side of the dam measurements were performed on spots that were available by the existing wooden scaffolding. These points were not geodetically recorded so these data are shown separately. Ten profiles were determined (UP: I - X), and distance between measurement points is 50 cm. From these profiles, this paper will show the results which were achieved after measuring only four central profiles: UP-IV, UP-V, UP-VI and UP-VII.

Excellent quality of concrete is indicated on the parts of the profiles: UP-IV, UP-V, UP-VI and UP-VII.

**On the profile UP-IV** indications for the excellent quality of concrete was obtained at point 6, (4530 m/s), of concreted part V (5th) at point 5 (4553 m/s), part VI (6th) of point 10 (4504 m/s), and parts IV-V - interruption in the concreting.

**On the profile UP-V** such indications were obtained at a point 7, V (5th) part of concreting (4595 m/s), and point 4, concreted part VI (6th) - 4500 m/s.

**On the profile UP-VI** indications are obtained on the following concreted parts and points: part III (3rd), points 17-21 (4554-4720 m/s), part VI (6th), point 4 (4500 m/s), and part VII (7th), measuring points 2 and 3 (4869 m/s and 4887 m/s). It should be noted that results on points 2 and 3, part VII, indicating the highest quality of concrete obtained by these tests. Also, the similar results which are obtained in the discontinuation of concreting zone in the part II-III, point 22 (4530 m/s) shows that concrete quality is very good.

**On the profile UP-VII** the indication were obtained on: part III (3rd), points 16 and 19, (4506 m/s and 4734 m/s), part IV (4th), points 12, 13 and 14, (4644, 4619 m/s and 4706 m/s), part V (5th), point 9 (4568 m/s), part VI (6th), point 4 (4555 m/s) and part VII (7th), point 2 (4534 m/s). These indications are obtained in the discontinuation of concreting zone in the part IV-V, point 11 (4582 m/s) and part V-VI, point 7 - 4835 m/s.

- *Insufficient quality of concrete* - is obtained only at one measuring point in the discontinuation of concreting zone in the parts VI-VII, on the UP-VII.
- *Good quality of concrete* - is obtained in the most points, the lowest value of speed in this separate category is 3570 m/s, obtained in the part V of the profile UP-V.
- *Excellent quality of concrete* – is obtained at several places along the profiles and concreted parts.
- The results from vertical and horizontal line indicate the good and excellent quality of concrete in the concreted sections as well as good quality concrete with interruptions in concreting zones.
- The most number of average velocity results (vertically and horizontally) is above 4000 m/s, which is in the upper half of the separate categories of concrete - good.

Since the concrete is, during its lifetime, exposed to negative effects such as chemical processes and atmospheric effects (mostly frost), it is recommended to observe its condition, so the adequate procedure can be taken, due to bring concrete in a state which is given by the project.
