APPLICATION OF DIGITISATION 3D-MEASURING EQUIPMENT FOR IDENTIFICATION OF FAILURE OF BELT CONVEYOR

Bigoš Peter¹, Mantič Martin¹, Kopas Melichar¹

Abstract: There is described in this paper a special measuring method of the FLEXOWELL belt conveyor in order to identify causes of a strong, excessive belt wear during current operation. There was applied an original measuring methodology based on application of 3D-measuring equipment, which is presented in this article.

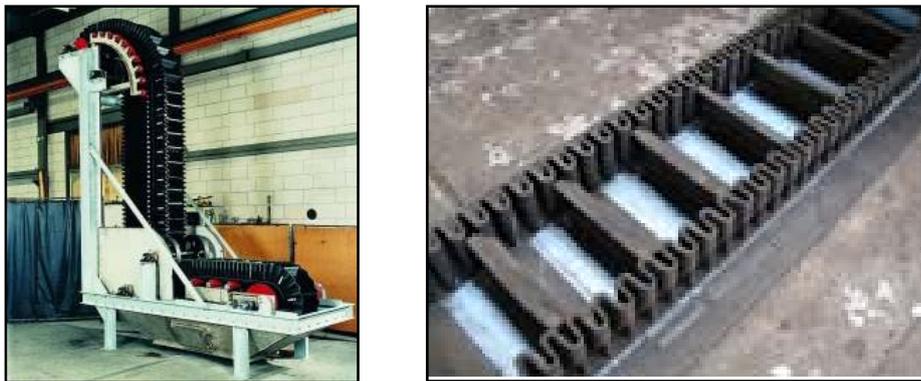
Figure 1 - The FLEXOWELL belt conveyor (www.meteoro.pt; www.vvvmost.com)

There is a special category of belt conveyors, which enable transport of bulk material vertically. It is category of the FLEXOWELL conveyors (Figure 1). Conveyors of FLEXOWELL type are used for vertical transportation of the bulk materials in situations where is limited space for installation of classic belt conveyor or other kind of conveyor system. They are able to transport any type of bulk material: from very small grain size bulk materials to large piece ore (Jasaň et al. 1989). Most common transported materials are: ore, coal, fly-ash, gypsum, stones, gravel, sands, fertilizers, lime stones etc. (www.vvvmost.com). The conveyed material is protected against external impacts and dust nuisance related to conveyor operation is minimized, as well. The FLEXOWELL conveyor belts are designed for combined transport directions, i.e. for horizontal, steep inclined and vertical transport. Granularity of

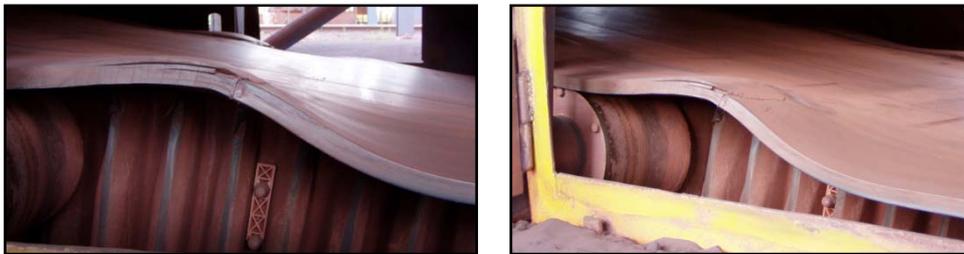
Figure 2 - Strong wear of the FLEXOWELL belt

In the framework of a cooperation between our Department and industrial background we had to solve a special task originating in industrial practice: in a certain industrial plant, which is equipped with the FLEXOWELL conveyor, occurred a very serious problem concerning this conveyor, namely it was a rupture of the belt. The concrete task was to investigate a real cause of such very serious negative phenomenon. During a current operation of this conveyor arose an excessive wear of the belt after a relatively short time of running (Figure 2) and this fact led to the rupture finally.

After visual inspection it was observed a distinctive wear of running surface of belt, which is in permanent contact with guiding cylinders (called also "dumbbell"). In order to determine the exact cause of belt wear it was necessary:

However, according to eccentric wear of running surface of belt, which is in permanent contact with guiding cylinders, it can be expressed a judgment about negative impact of "dumbbells" misalignment on the belt loading (i.e. additional eccentric loading).

But the most relevant cause of the belt damage seems to be quality of the belt joint. According to the X-ray diagnostics of the join was evident a poor quality of joining process realisation and loss of contact between steel wire ropes and rubber covering layers.

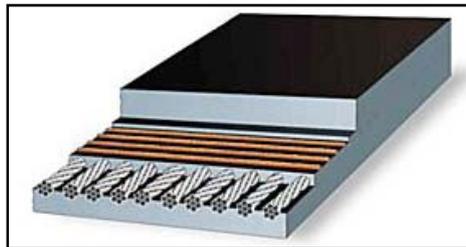
Figure 3 - Internal structure of the belt with steel cord (www.phoenix-cbs.com)

The carcass of belt consists of a high-strength steel cord placed in one plane embedded in the rubber and it is safeguarding the perfect joint between upper and lower cover layer, Figure 3. Such structure provides high performance and resistance of the conveyor belt.

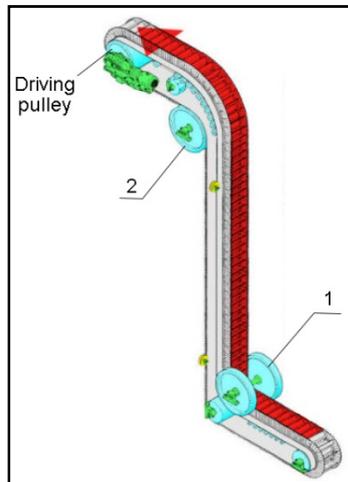
Figure 4 - Scheme of arrangement of guiding cylinders (www.flexowell.pl)

One of possible causes of conveyor belt damaging is insufficient accuracy of their geometrical set-up. From this reason it was necessary to verify deviations of arrangement of both "dumbbells" in the conveyor supporting steel construction. There is illustrated a simplified scheme of the FLEXOWELL conveyor in the Figure 4, with marked position of concerned guiding cylinders, i.e. positions No.1 and No.2.

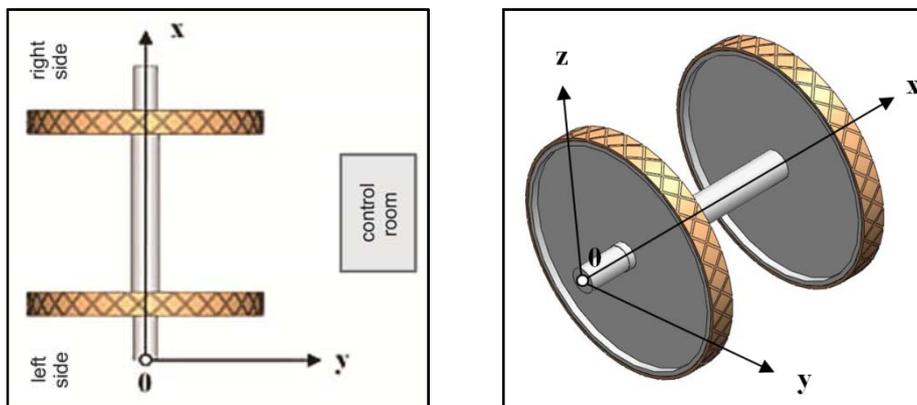
Figure 5 - Arrangement of the coordinate system

In order to determine the angular deviations of "dumbbells" there was defined a spatial orientation of them related to the control room of plant, Figure 5. The beginning of the coordinate system "0" was situated on the left side of the "dumbbell" (in the place of bearing house middle point) and the x -axis is axis of "dumbbell" rotation.

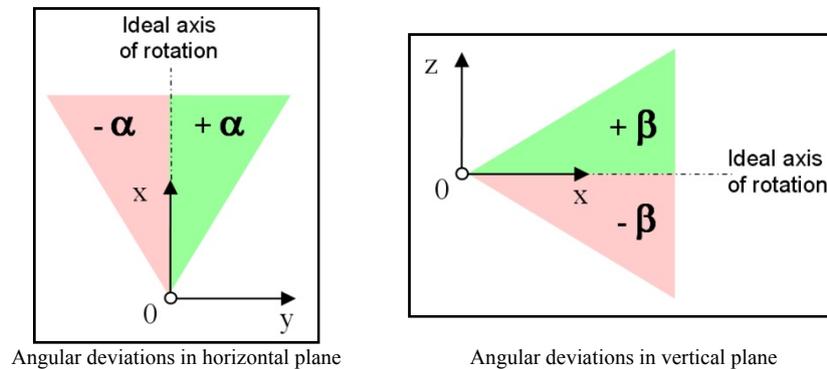
Figure 6 - Sign convention for angular deviations

There was defined a sign convention according to the Figure 6 for the given coordinate system in order to determine direction of angular deviation.

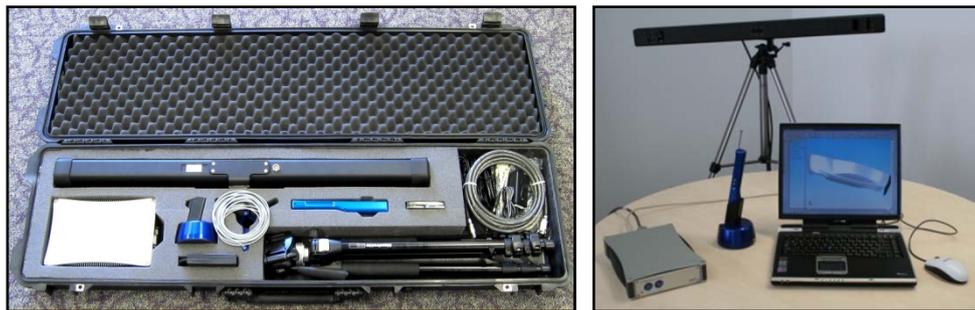
Figure 7 - Measuring apparatus 3D Creator

The measuring process was realised by means of the 3D-measuring and digitalisation scanner 3D Creator with infrared data transmission (Figure 7). It is a product of the company Boulder Innovation Group, Inc. The measuring equipment was supplied also with special preparations designed for set-up of reference points and the laser distance-meter Leica DISTO. The described measuring methodology was applied for measurement of geometrical deviations of both guiding cylinders.

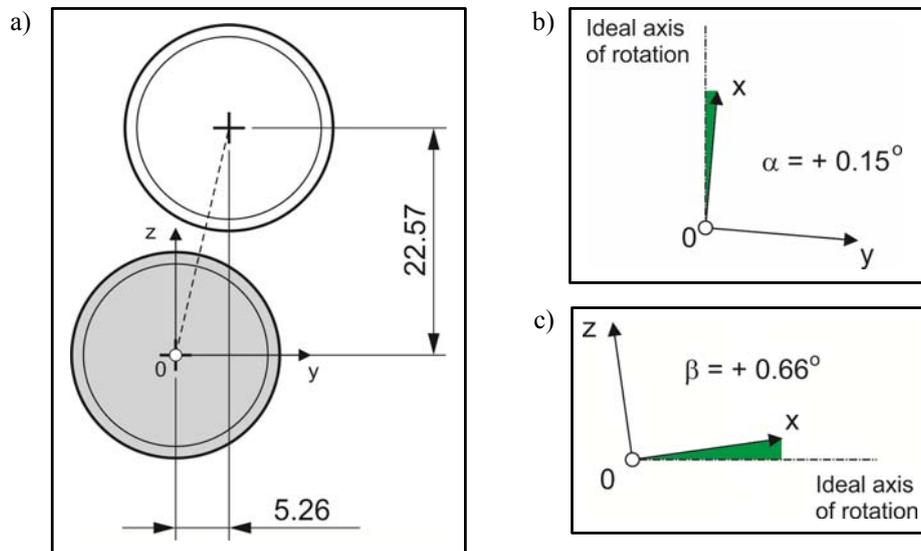
An example of the measured deviation values of the "dumbbell" No.1 is presented in the Figure 8, where the 8a represents deviations of length in horizontal and vertical plane and 8b and 8c represent angular deviation in horizontal/vertical plane. Similar results were obtained in the case of the "dumbbell" No.2.

It was already mentioned that visual inspection of belt discovered a distinctive wear of running surface of belt, which is in permanent contact with guiding cylinders and analogical wearing was visible also on the surface of running surface of guiding cylinders in the extension of half width of running area. This fact corresponds to the geometrical deviations of both "dumbbells" as a possible cause of additional and eccentric loading of the belt.

Figure 8 - Measured deviations of the "dumbbell" No.1
 a) Deviations of length in horizontal and vertical plane; b) Angular deviation in horizontal plane; c) Angular deviation in vertical plane.

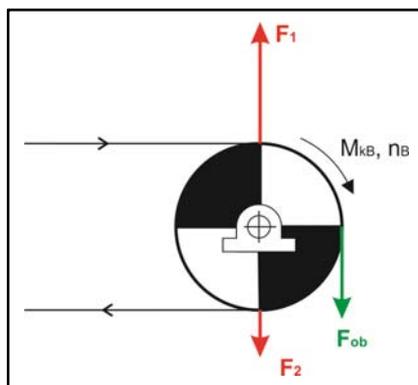
Figure 9 - Force situation on driving pulley

The driving pulley is situated in the point of maximum tension force. Therefore the belt tension forces are analysed in the driving station, Figure 9.

F_1 - maximum tension force;
 F_2 - minimum tension force;
 F_{ob} - circumferential driving force;
 M_{kB} - driving pulley torque;
 N_B - speed of driving pulley.

There are known following relations among individual forces from the Figure 9:

Thus, the maximum permissible force F_{max} in the belt is 350,000 N. So it is evident that $F_{max} \gg F_1$ thanks to high level of tension safety coefficient of belt. The belt is over-dimensioned more than six-time and its tensile strength is sufficient enough.
