LABORATORY TESTING OF SHEAR PARAMETERS THROUGH ROCK MASS AND ALONG DISCONTINUITIES – THE KOMARNICA DAM

Abstract: The paper shows the results of laboratory geo-mechanical tests of shear parameters (c - cohesion and φ - angle of internal friction) established on representative samples isolated at the site of construction of concrete arch dam Komarnica in Montenegro. For the testing of parameters of shear strength through rock mass, representative samples were used isolated from exploration wells. Testing of shear strength along fractures was made on cylindrical samples, which were isolated in exploration galleries. The paper shows test methods, analyses of results and concluding analysis. Tests on fractures were made at the Institute for the Development of Water Resources "Jaroslav Černi" in Belgrade, and tests of shearing through mass at the Faculty of Mining and Geology in Belgrade.

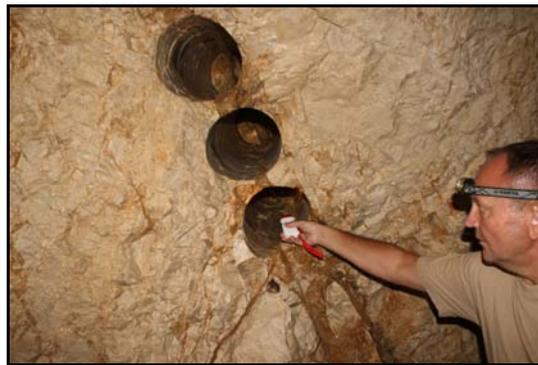
Figure 5 - Locations where cylindrical samples of the rock mass along the fracture were taken in order to carry out one series of testing

Testing of shear strength along the discontinuity was carried out on the total of 40 samples. Samples to be tested were extracted from all galleries at the dam site by application of the core drilling method along the strike of the representative discontinuities (Figure 5).
