OPEN-PIT "FILIJALA" NORTHWEST SLOPE STABILIZATION IN ORDER TO REDUCE DAMAGE RISK AND ENVIROMENTAL PROTECTION

Čebašek Vladimir¹, Gojković Nebojša¹

Abstract: The development of the marl exploitation in the open pit "Filijala" caused the instability appearance in northwest final slope area. The location of this part of the mine in relation to surrounding objects demanded stabilization of the slope in order to prevent further spread of damage. For these purposes, a detailed analysis of the current state of slope stability were carried out, which used as a basis for determining appropriate stabilization measures for the slope.

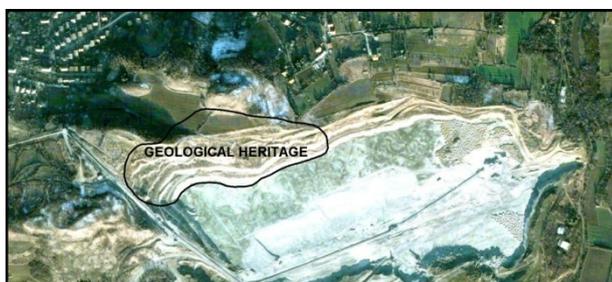
In the specified area of the open pit a geological heritage was recorded, with the best development of Pannonian period (Figure 4). For the above reasons, the Institute for Nature Conservation of Serbia passed a decision in which the northwestern part of deposit "Filijala" in mining area "Severno polje" with area of 24,720 m² in was excluded.

Figure 4 - Part of marl deposit "Filijala" with the best development of Pannonian period (geological heritage)

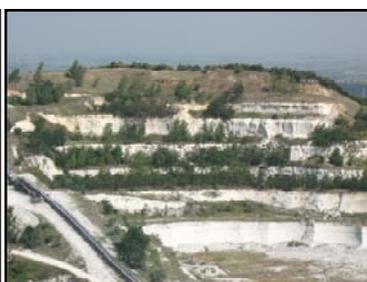
Figure 5 - Open pit "Filijala" slope appearance with the best development of Pannonian period (geological heritage)

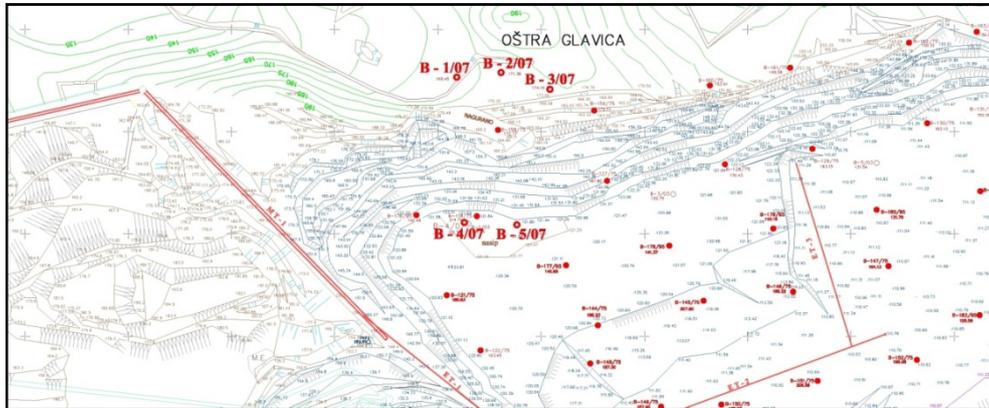
The analysis of existing technical documentation for "Filijala" marl deposit determined that on the basis of available geomechanical data it is not possible to verify stability of the northern part of the open pit (Figure 6). For these reasons, additional research was conducted in order to determine detailed geological structure of this part of the deposit, and to supplement the necessary geotechnical data of the characteristic lithological units. This research covers the drilling of five exploration boreholes, which are shown in Table 1, detailed geological and geomechanical mapping of core drilling was carried out, hydrogeological testing, sampling and geomechanical laboratory testing (Gojković and Čebašek, 2007a).

Figure 6 - North slope of open pit "Filijala" in which area additional research and slope stability analyses were conducted

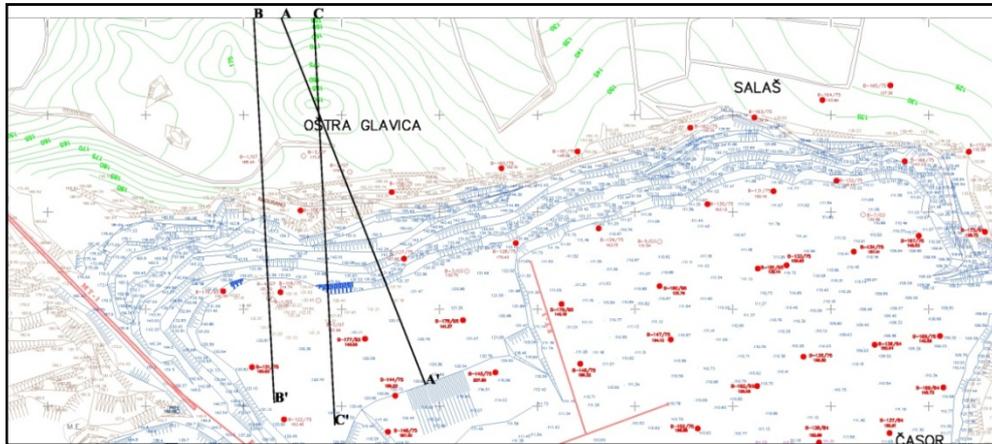
Figure 7 - North slope of open pit "Filijala" with position of geological-technological sections A - A', B - B' i C - C'

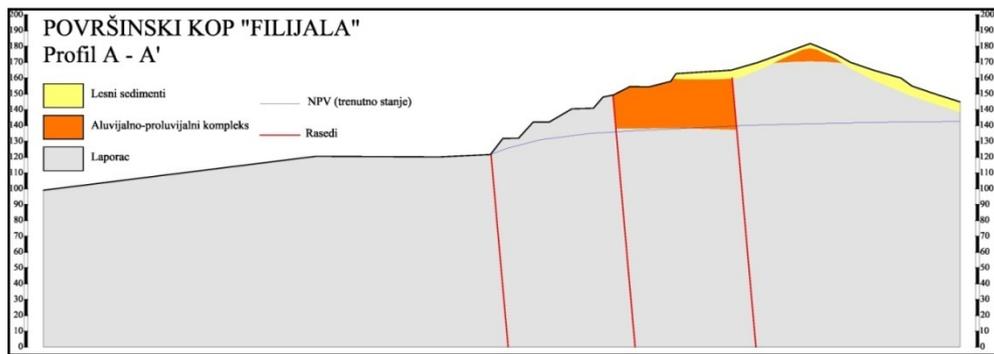
Figure 8 - North appearance of section A - A'

Sections that were analyzed consisting of marl complex, alluvial-prolluvial complex and loess deposits, Figures 8, 9 and 10. There are three faults in each section, in a slope toe, at the slope head and the third is located behind the top of slope and below the incline called "Oštra glavica". The geometry of the slope of individual sections is shown in Table 2 Taking into a account the geological structure and the geometry of the slope stability for further calculations the finite element method was adopted (www.rocscience.com, 2001-2004; www.rocscience.com, 2005).

Final slope stability analysis with applied stabilization measures by constructing the counterweight embankments in toe part of the slope in this part have defined the safety factors which amounted $F_s = 1.38$ (section A - A'), $F_s = 1.32$ (section B - B') and $F_s = 1.39$ (section C - C'). The analysis of the distribution of maximum shear strain (Figures 17, 18 and 19) shows that the maximum concentration is in the zone below the toe of embankment slope, which is fully consistent with the required minimum value of safety factor $F_{smin} = 1.30$. Here it should be noted that the potential slide plane with a minimum safety factor of slopes in all analyzed sections with applied stabilization measures is located in the zone of the embankment slope. This indicates that the overall slope with applied stabilization measures safety factor is greater.
